AMMRC CTR 75-29

PARAMETRIC STUDY OF DIFFUSION
BONDED BUTT JOINTS

M.E. GULDEN, A.G. METCALFE AND E.C. THORSRUD

SOLAR DIVISION OF INTERNATIONAL HARVESTER
P.O. BOX 80966
SAN DIEGO, CALIFORNIA 92138

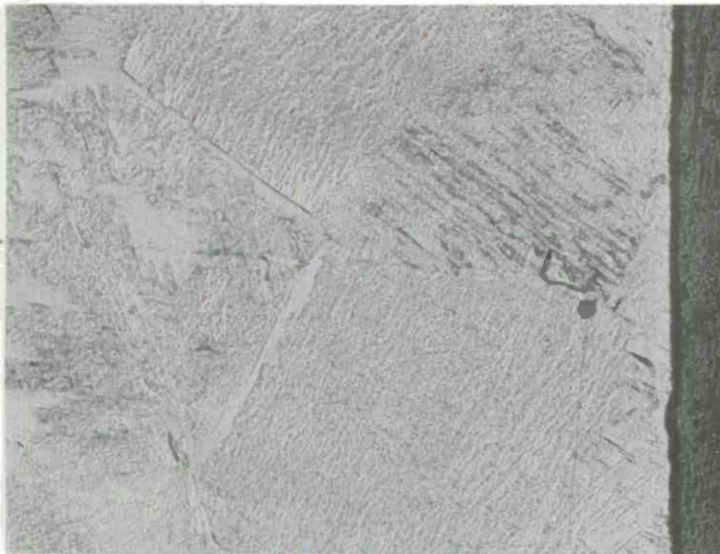
d) Round corner (8 min acid clean)

Magnification: 200X

Figure 28. Effect of geometric variables on joint quality

Based on appearance of the joint region, the rounded corner condition (Figure 28e and 28h) had little effect on joint quality.

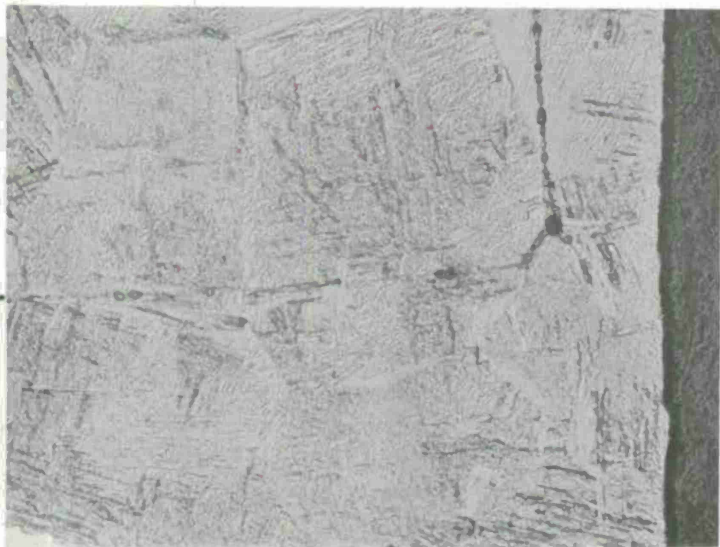
e) Round corner (4 min acid clean)

Magnification: 200X

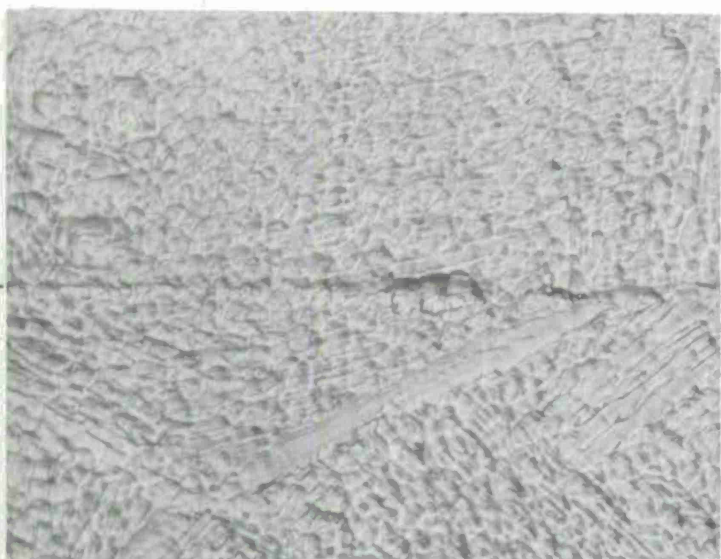
a) 1350° F

b) 1600° F

Figure 33. Effect of heat treatment on bond line indications for good quality joint .

Etchant: 2 min Kroll's
+ 4 sec CSDB.

Magnification: 1000X.

c) 2000° F

Examples of the resulting microstructures are shown in Figures 33 to 36. Except for fingerprint contamination, a heavy overetch condition was necessary to reveal the bond line indications. For comparison purposes, the standard heavy etch was used for all the photomicrographs. In all cases, the area of heaviest etching is shown. No difference in bond line appearance was observed with the three heat treatments for a good quality joint (Figure 33). This indicates that the specie responsible for the etched indications is not readily soluble in the titanium matrix. In the absence of diffusion data, Table 5 lists some of the potential gaseous contaminants and their respective atomic sizes and solubilities in titanium. Small amounts of hydrogen, carbon, oxygen and nitrogen would be readily dissolved at both 1600 and 2000° F. These elements are considered interstitial due to their relatively small size compared with titanium atoms (1.46Å). Argon, sulfur and chlorine are expected to behave as substitutional elements and their solubility in titanium is probably quite low and consequently diffusion rates are expected to be very low. Compound formation

Figure 35 shows a poor quality joint which failed by flat fracture in the mechanical tests. Again, there is no appreciable difference in the bond line indications for the three heat treatments. Although the size of the indications is essentially the same as for a good quality joint (Figure 33), the number of indication is much larger, giving an almost continuous decoration of the bond line. This observation suggests that the occurrence of flat fracture is not dependent on the size of indications of the bond line, but on their number. This particular panel was bonded using low-heat processing parameters.

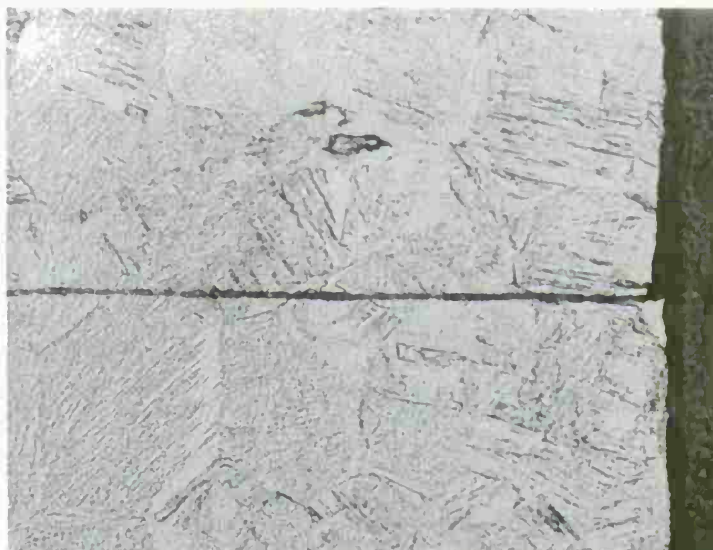
Area of ultrasonic indication -
Category 7.

Etchant: 2 min Kroll's + 4 sec
CSDB.

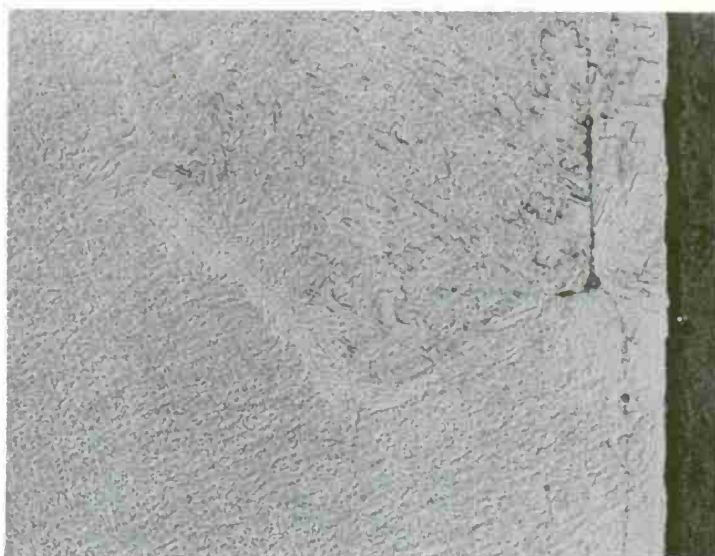
Area of ultrasonic indication - Category 9.

Etchant: 2 min Kroll's + 4 sec CSDB.

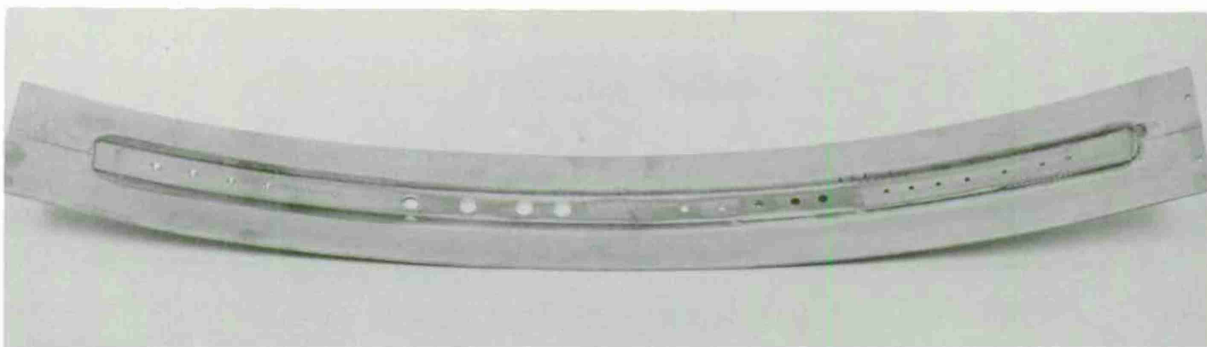
Figure 55. Panel prepared to evaluate repair techniques.

To establish and evaluate repair techniques, a series of different size holes, 1/8 inch, 1/4 inch and 1/2 inch diameter were drilled and reamed through a standard panel to simulate the removal of voids or inclusions. Surface damage was simulated by 1/8 inch, 1/4 inch and 1/2 inch diameter drill points into the surface of the panel, approximately 1/16 inch deep. Figure 55 shows the panel before repair.

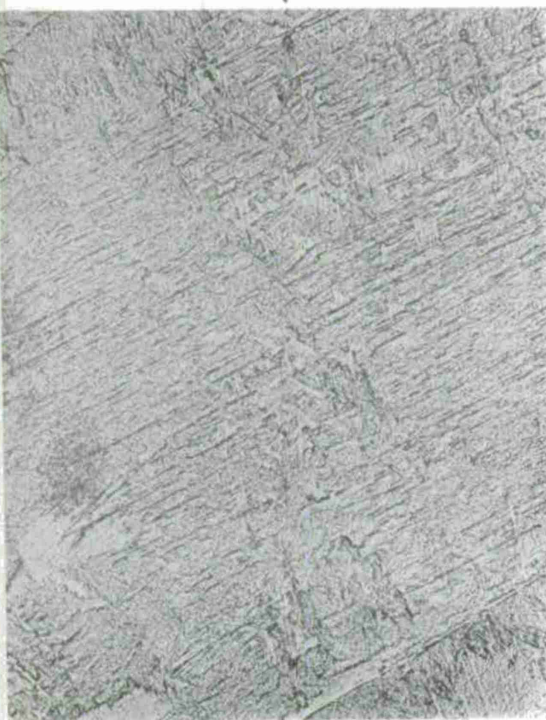
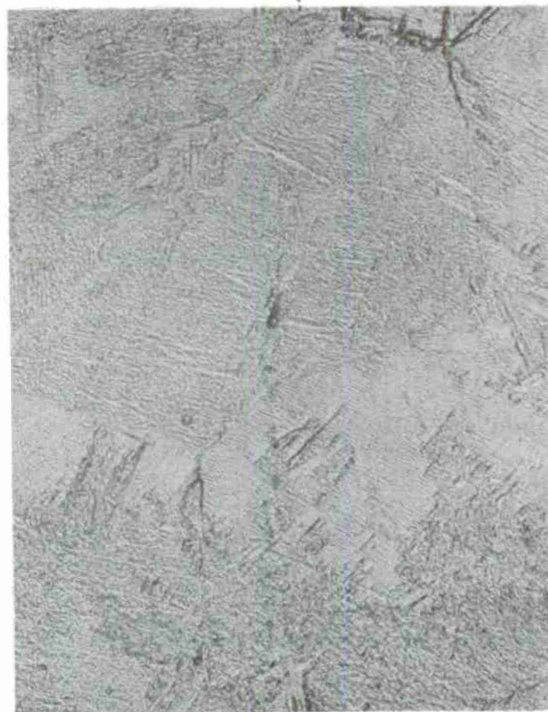
a) Magnification: 8X.

b) Magnification: 200X.

Figure 57. Microstructure of repair section containing 0.25 inch diameter plug.
Etchant: 2 min Kroll's + 4 sec CSDB.

Examples of the microstructure in the repair areas are shown in Figures 57 and 58. The location of the plugs was apparent from grain structure differences as shown in Figure 58a. As can be seen in the photomicrographs, a good to moderate quality joint was formed at the plug-panel interface. Grain growth across the bond line was noted throughout the section and the special overetching method was required to reveal any indication of the bond line. An example of the joint region in the panel bonded twice is given in Figure 59. The only noticeable difference in structure from a single pass panel is an increase in grain size.
